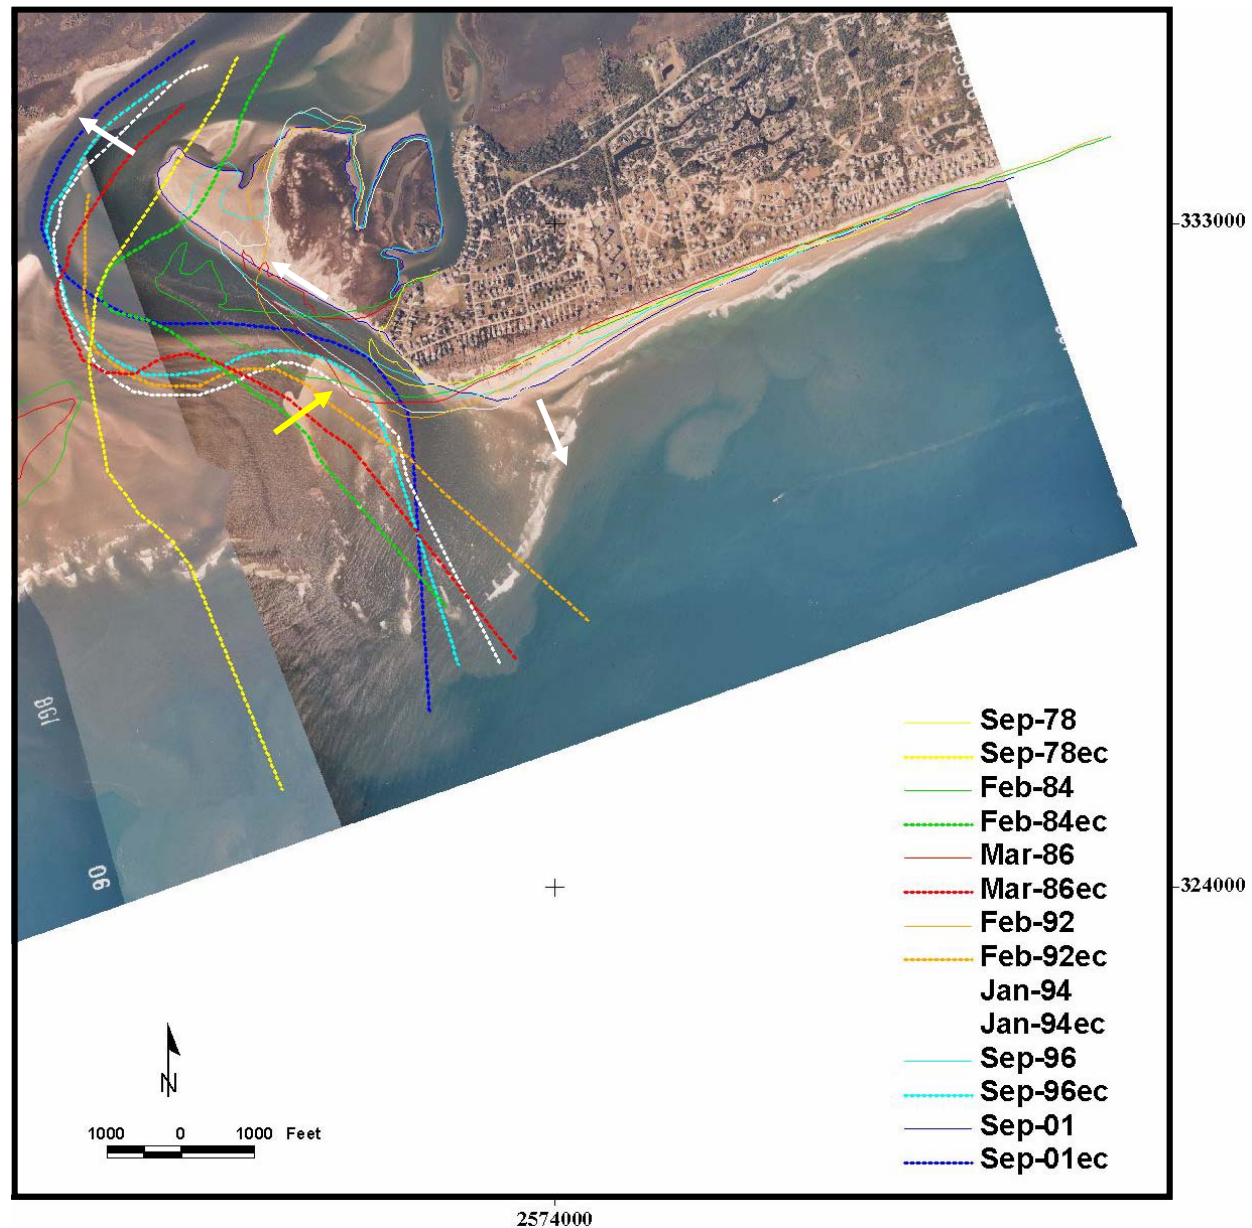
Figure 25. Aerial photograph mosaic (9/18/01) depicting position of axis of ebb channel and shoreline positions along Bogue Banks between 1978 and 2001. Note relationship of eastward movement of ebb channel, northwestward extension of estuarine spit and channel encroachment upon Dudley Island.
